# ULTRASOUND TOMOGRAPHY AND 3D SCANNING TECHNOLOGIES AS A TOOL TO CONSTRAIN THE WEATHERING STATE OF OBJECTS MADE OF MARBLE

## Abstract:

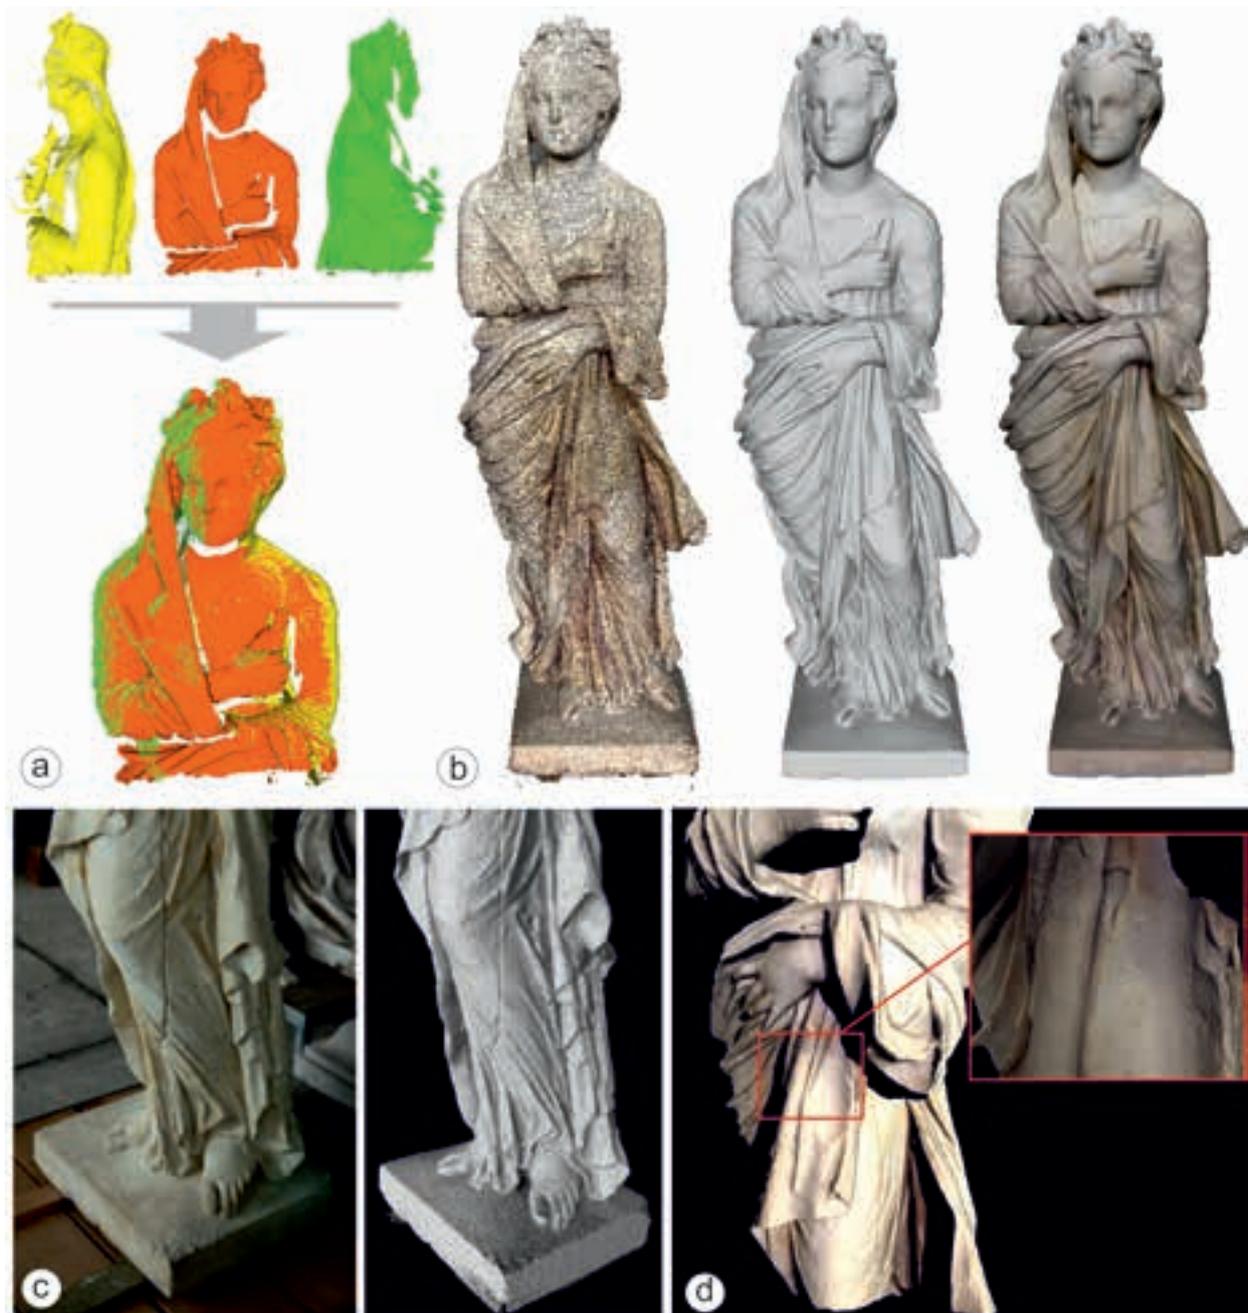
**Figure 2:** Steps to generate complete reconstructions from multiple views. (a) Alignment of partial point clouds. (b) Point cloud, mesh and textured mesh of the reconstruction. (c) and (d) show how the high-resolution reconstructions can document even small damages in the object's surface.

cally. Figure 2(a) illustrates how point clouds from three views are merged. The pictures demonstrate the process on a Vestalin statue from the Skulpturenhalle Potsdam. In order to achieve a closed, high-precision reconstruction with appropriate data size, a mesh is generated from the point cloud that approximates the surface of the object. A well established method that is Poisson Meshing (see Kazhdan et al. 2006). Finally, a texture and optionally a normal map are mapped onto the mesh (see Noll and Stricker 2011). Figure 2(b) visualizes this process. In this way, high-resolution detailed objects with comparatively low memory requirements can be rendered and displayed according to modern standards. Figure 2(c) and (d) illustrate the high quality of the reconstructions. Even very small damages such as cracks or spallings in the surface can be detected and documented. Figure 2(c) shows on the left a high resolution image and on the right the reconstructed point cloud of this region. Figure 2(d) depicts a colored point cloud, where the damaged area is enlarged in the inset.

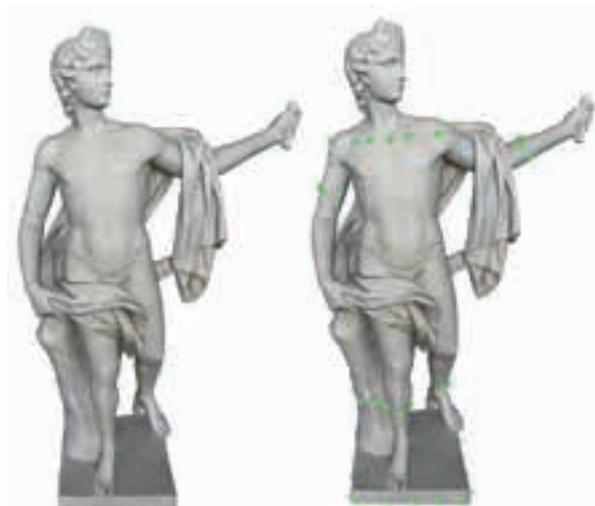
**Figure 3:** Reconstruction of Apoll without (left) and with (right) measuring points of ultrasound tomography.

campaigns. In this study, for example, the exact position of the measuring points for the applied ultrasound tomography could be documented. In this way they can be clearly assigned and improve the repeatability of further measurements. In addition, they enhance the aligning of the computed tomograms, which helps to compare them with visible decay phenomena. In order to augment the reconstruction, we perform high quality 3D scans to obtain the model. The ultrasound tomography is then applied and the measuring points are marked on the object. Again a reconstruction of the areas with the marked measuring points on the object is carried out. The coarse reconstruction is aligned with the previous one and the measuring positions are extracted according to this alignment. They are stored separately and can be augmented to the high-resolution reconstruction if required. Note that the accuracy of the measuring points depends on the resolution of the second scan and the alignment, which can be tuned accordingly. Fig. 3 shows a reconstruction of Apoll from the Skulpturenhalle Potsdam, for which measuring points are shown (right) and hidden (left) if required.

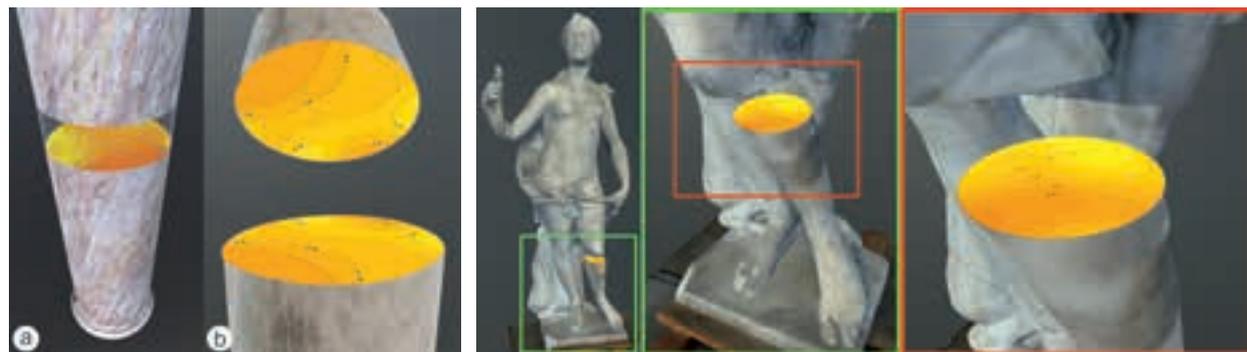
**Figure 6 and 7:** Reconstruction of Kauffunger column (a), Prieborner column (b) and Diane (c) Potsdam including the computed tomograms. The left carf is cut off to make the measured tomography visible(d).

due to slippage and movement of the foil, these problems do not occur at all with the automatic approach. In Figures 6 and 7 the computed tomograms are placed at the reconstructions. Due to the documentation of the transducer positions as described before, it is possible to position the tomograms perfectly at the reconstruction. Therefore, correlations between macroscopically visible decay phenomena, structural properties as the orientation of the foliation and the tomograms can be analysed immediately. The combination of both previously described methods, allows an accurate, and in depth investigation as well as being a great monitoring basis and allows many visualization possibilities.
